Manhole Inspection Summary

Manhole # S33AA_019MH

Insp Date: **5/28/09 3:16 PM**

Location Address: **835 HOWARD ST**

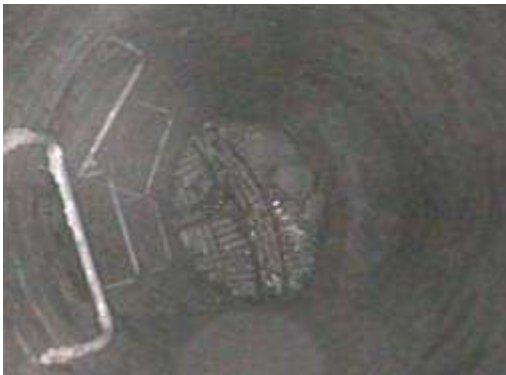
Defect 1

Count: **10** Missing: **0** ☒ **Corroded**

☒ **Evidence Of Surcharge** Depth: **2** (ft.) ☐ Active Surcharge Present

corroded step and evidence surcharge

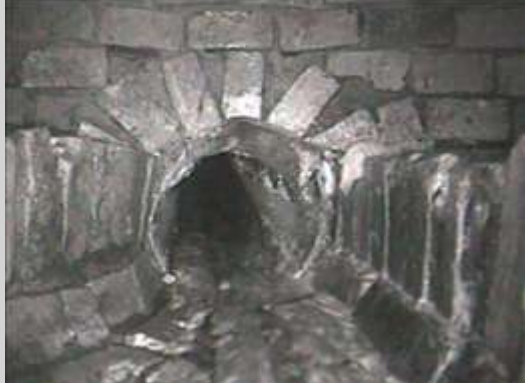
12 O'Clock Outflow

8 in. Circular Gravity Sewer
Pipe Out @ 12 O'Clock

Pipe Height: (in.) Direct
Pipe Material: **Clay** ☒ Pipe Lined
Invert Depth: **16.43** (ft.) Flow Characteristics: **Fast**
Deposits: ☒ None ☐ Mud ☐ Sludge ☐ Debris ☐ Grease
Silt Depth: (in.) Deposits Extent:
Infiltration: **None** Pipe Seal Cond: **Sound**

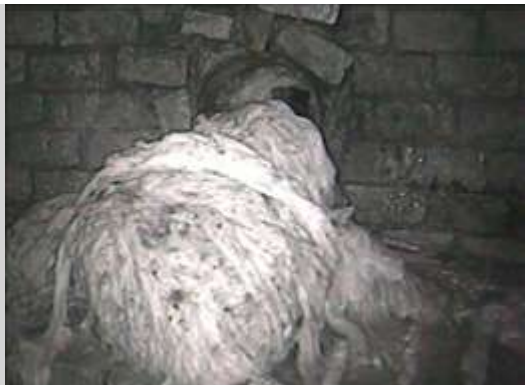
3 O'Clock Inflow

6 in. Circular Gravity Sewer
Pipe In @ 3 O'Clock

Pipe Height: (in.) Direct
Pipe Material: **Clay** ☐ Pipe Lined
Invert Depth: **15.69** (ft.) Flow Characteristics: **Slow**
Deposits: ☐ None ☐ Mud ☐ Sludge ☒ **Debris** ☐ Grease
Silt Depth: **0** (in.) Deposits Extent: **Heavy**
Infiltration: **None** Pipe Seal Cond: **Sound**

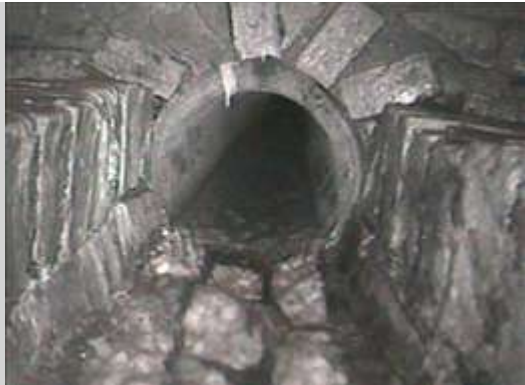
7 O'Clock Inflow

8 in. Circular Gravity Sewer

Pipe In @ 7 O'Clock

Invert Depth: **15.31** (ft.) Flow Characteristics: **Fast**

Deposits: ☒ None ☐ Mud ☐ Sludge ☐ Debris ☐ Grease

Infiltration: **None** Pipe Seal Cond: **Sound**

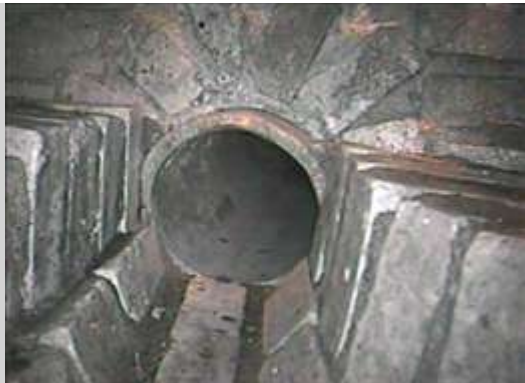
9 O'Clock Inflow

6 in. Circular Gravity Sewer

Pipe In @ 9 O'Clock

Invert Depth: **16.29** (ft.) Flow Characteristics: **Slow**

Deposits: ☒ None ☐ Mud ☐ Sludge ☐ Debris ☐ Grease

Infiltration: **None** Pipe Seal Cond: **Sound**
